IN RE: ETHICON, INC.,

PELVIC REPAIR SYSTEM PRODUCTS

Master File No. 2:12-MD-02327 MDL 2327

Intentional Oxidation of Prolene Mesh – Part 2 Supplemental Report of Dr. Shelby F. Thames September 28, 2016

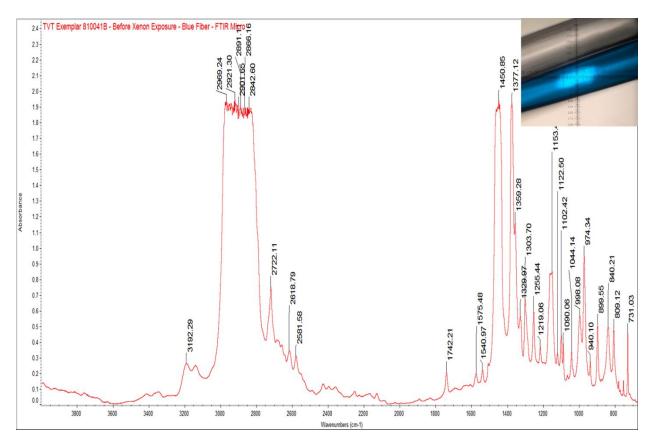
Figure 6. Pristine TVT Exemplar 810041B - Before Xenon Exposure - Blue Fiber

The pristine TVT exemplar sample was characterized via Fourier Transform Infrared Microscopy (FTIR) with a Thermo-Nicolet Continuum FTIR Microscope (Figure 5) prior to UV exposure. The resulting spectrum (Figure 6) contains an inset image showing the penetrating IR beam location. The absorption frequency at 1742 cm⁻¹, indicative of Ethicon's DLTDP antioxidant, is also noted in my previous reports, which I rely upon, and is present in the spectrum.

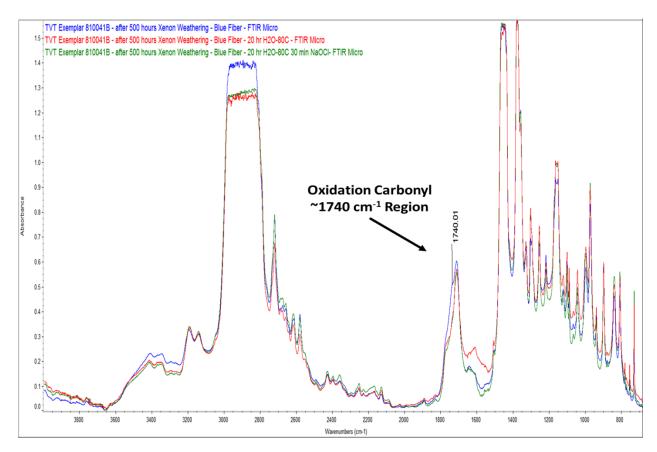
Figure 8. Overlay of Blue Fiber TVT Exemplar 810041B – After 500 hrs. Xenon Exposure (Blue Spectrum), After 20 hrs. Immersion in 80°C water (Red Spectrum), and After 30 min. Immersion in NaOCI (Green Spectrum)

Consequently, the oxidized TVT exemplar (Figure 7) was immersed in 80°C water for 20 hours, removed, dried, and analyzed via FTIR microscopy (Figure 8 – red spectrum). The oxidized TVT exemplar was then immersed in sodium hypochlorite solution (NaOCI) on a shaker for 30 minutes, removed, dried, and again analyzed via FTIR microscopy (green spectrum). Although there was no flesh present to utilize sodium hypochlorite's oxidizing capacity, the FTIR spectral overlay demonstrates that carbonyl (oxidation) absorption did not diminish during, and as a result of, the cleaning protocol (Figure 8). The cleaning process (Fig. 1) was continued, utilizing the intentionally oxidized TVT exemplar, with FTIR analyses conducted after each cleaning stage (see Figures 8 and 13).

The FTIR spectra of Figure 13 unequivocally verifies that the cleaning protocol of Figure 1 does not remove oxidized carbonyl moieties from Prolene. Moreover, should oxidized Prolene be present it will be seen as a strong carbonyl frequency at or near ~1740 cm⁻¹ (Figure 8)

Plaintiffs have posed the concept, without any scientific evidence, that our cleaning protocol (Figure 1) removes oxidation products formed and/or residing on Prolene's surface. However, purposeful oxidation of Prolene and subsequent cleaning proves unequivocally our process does not remove oxidized Prolene if it is present. When or if oxidized Prolene is present, as we have shown herein, it is evidenced by strong carbonyl absorption frequencies (Figure 8)². The carbonyl group(s) responsible for the strong absorption are not removed by cleaning.

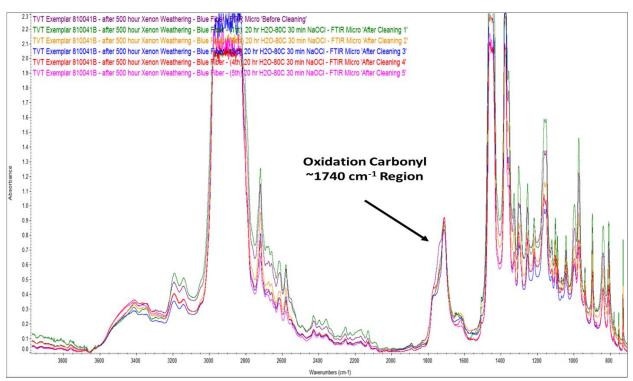
Figure 13. FTIR Spectral overlay of intentionally oxidized Prolene and the same sample after each of the cleaning steps highlighted in Figure 1.

The FTIR spectral overlay of Figure 13 confirms the carbonyl oxidation absorption of the intentionally oxidized Prolene sample has not diminished with progressive cleaning. This further proves the cleaning protocol does not deplete the carbonyl absorption of oxidized Prolene, should it be present in explanted samples.
